## **23. Fall**

A **52-year-old** Hispanic carpenter/laborer died after falling nine feet to the ground at a residential construction site. He was standing on a double top plate on an interior wall of the residence under construction before he fell. The double top plate measured approximately five inches in width. Access to the top plate was by a 10-foot step ladder. He was picking up unused nails from the top plate and handing them to a co-worker on the ground floor. The co-worker was positioned to reach for the nails from the victim when he looked away for a moment and then saw the victim as he hit the ground floor. Apparently, the victim lost his balance or footing on the narrow top plate. The victim was unconscious immediately after the fall. Emergency services were called and they transported him to a hospital, but there he was reported as deceased.

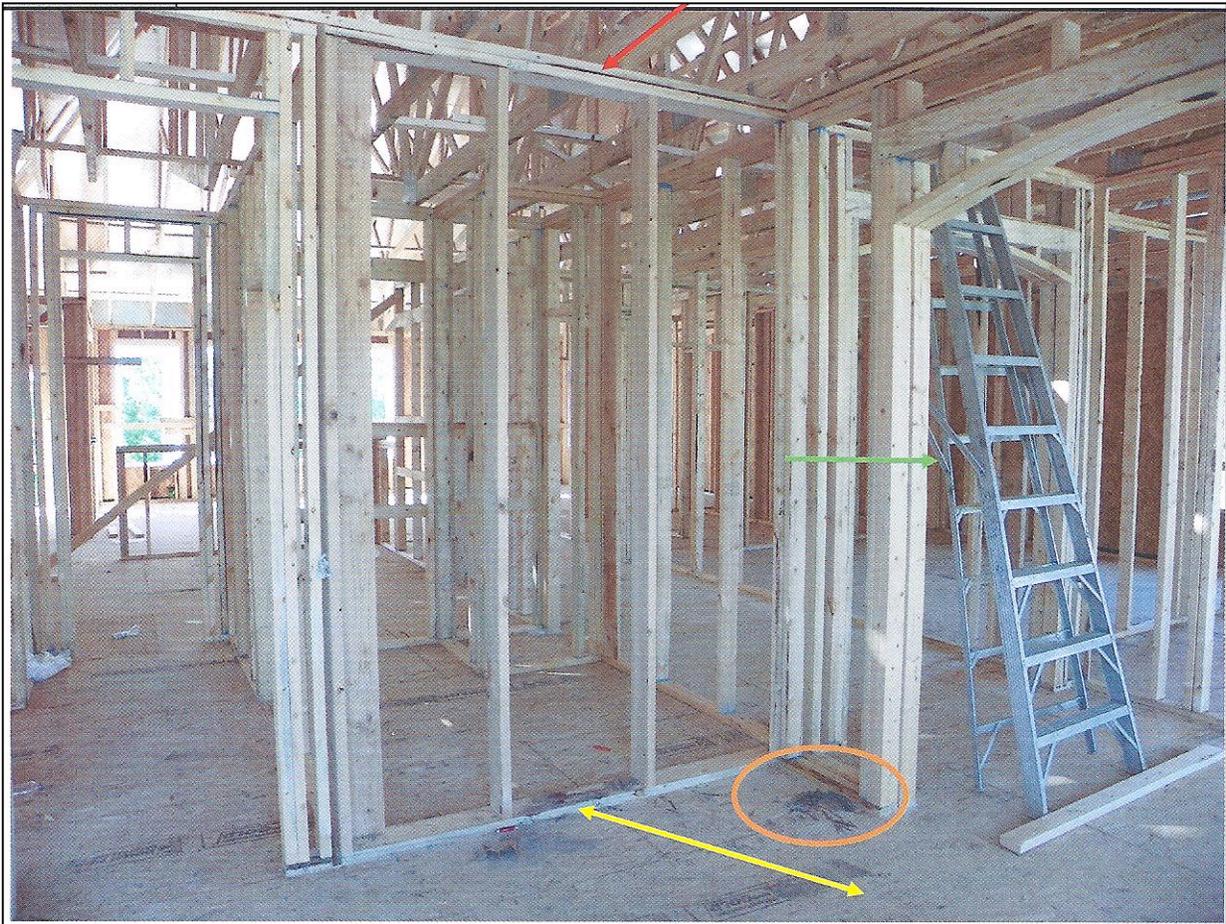
**See Photo on Next Page**

Red arrow indicates where the employee was working when he fell  
Yellow arrow indicated location of the employee after he fell  
Orange circle shows the nails the employee had collected  
Green arrow points to the step ladder used to access the top of the interior wall

Item 2 1926.501(b)(1)	Each employee on a walking/working surface (horizontal and vertical surface) with an unprotected side or edge which is 6 feet (1.8 m) or more above a lower level was not protected from falling by use of guardrail systems, safety net systems, or personal fall arrest systems.

Item 3a 1926.1053(b)(1)	Portable ladders were used for access to an upper landing surface and the ladder side rails did not extend at least 3 feet (0.9 m) above the upper landing surface to which the ladder was used to gain access.

Item 3b 1926.105(b)(4)	Ladders were used for purposes other than the purpose for which they were designed.
